New York State Department of Transportation  
Yellow Flag NB2358W022

BIN: 1065318

Feature Carried: 278I278IX2M23027

Feature Crossed: 6TH AVENUE

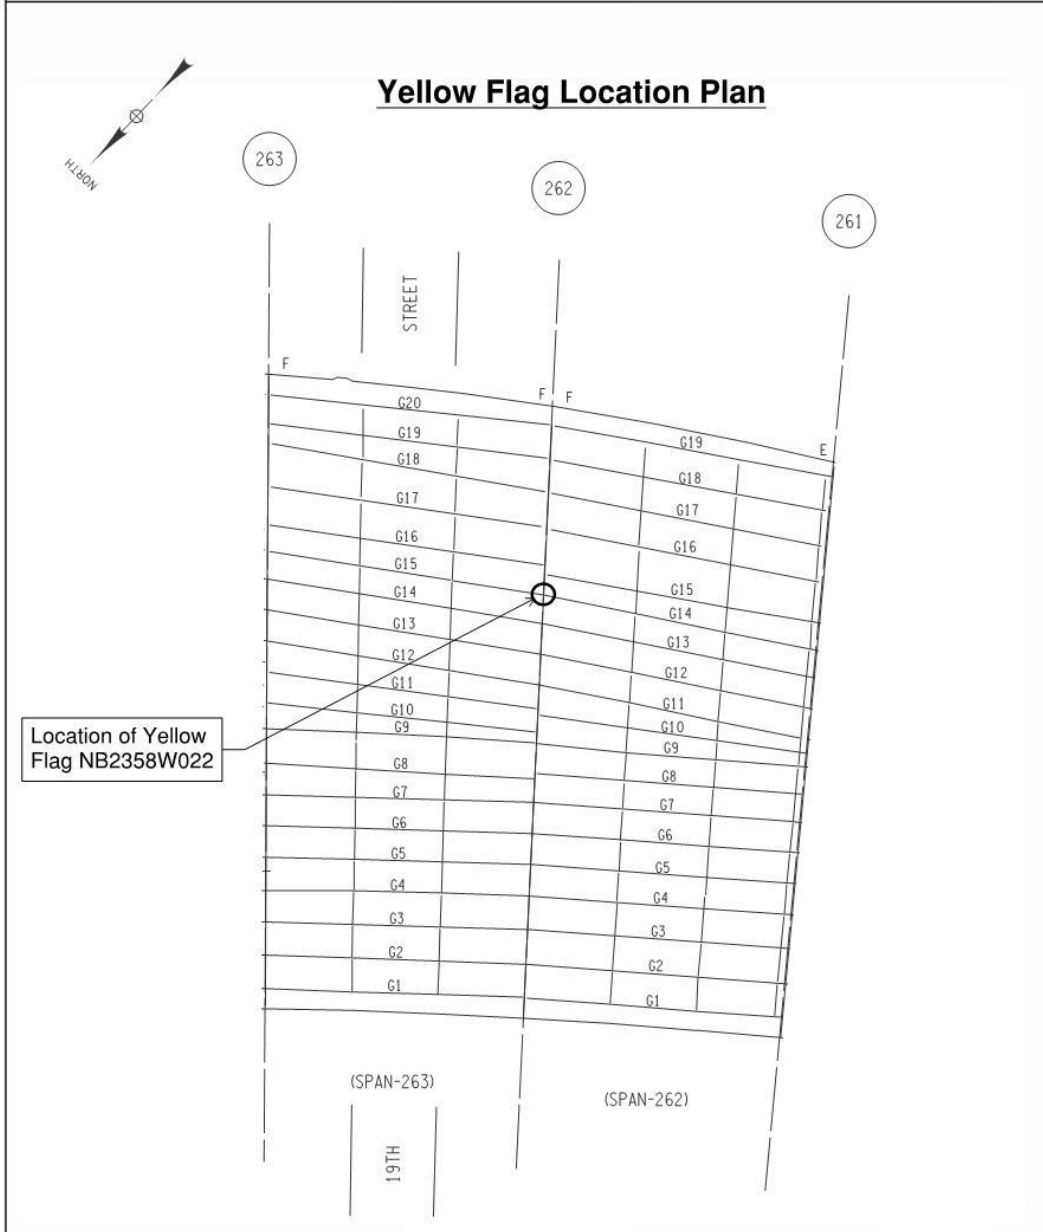
Photo Number: **1**

Attachment Description: Flag Location Plan

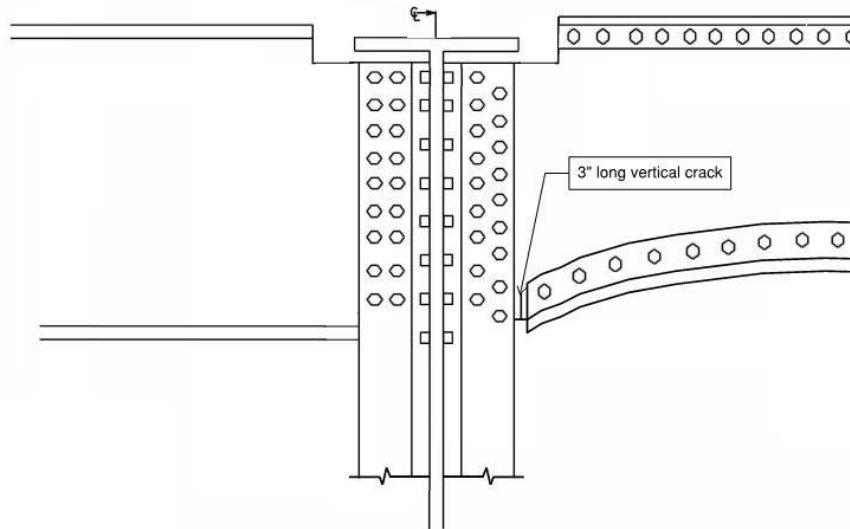
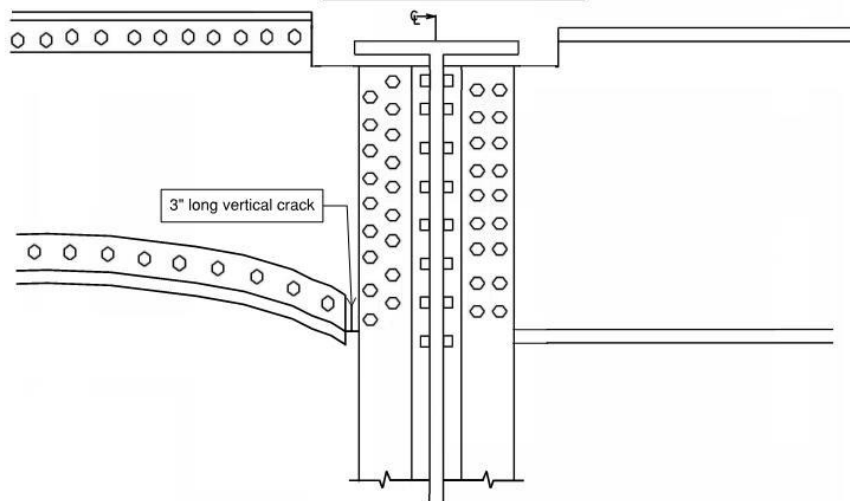
Photo Number: 2

The end of Girder G15 in Span 263 at Pier 262 exhibits a 3" long vertical crack in the lower web adjacent to the connection angle (Photo #6). The remaining girder web exhibits moderate corrosion in the upper web at the top cope with no significant section loss throughout the girder height (Photos #4 and #5). (refer to Flag Condition Sketch Photo #2 for more details)

**Attachment Description: Flag Condition Sketch**

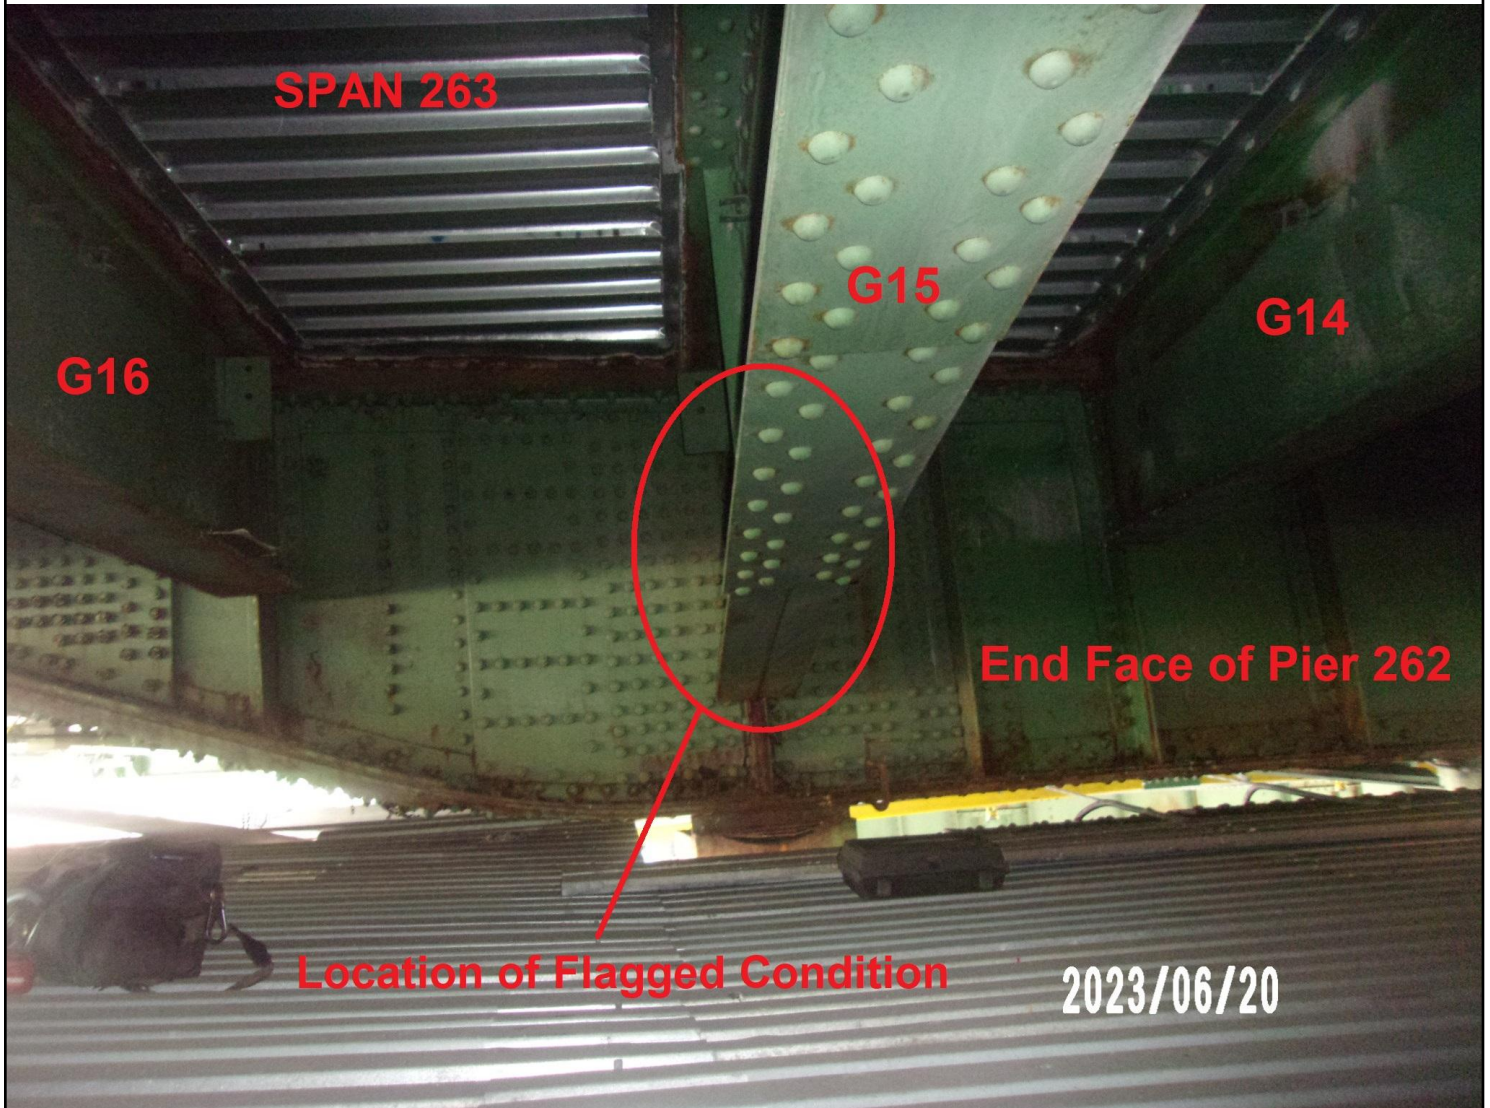
Photo Number: 3

**Attachment Description:** General view of the flagged condition at Girder G15 in Span 263 at Pier 262. Looking Begin.

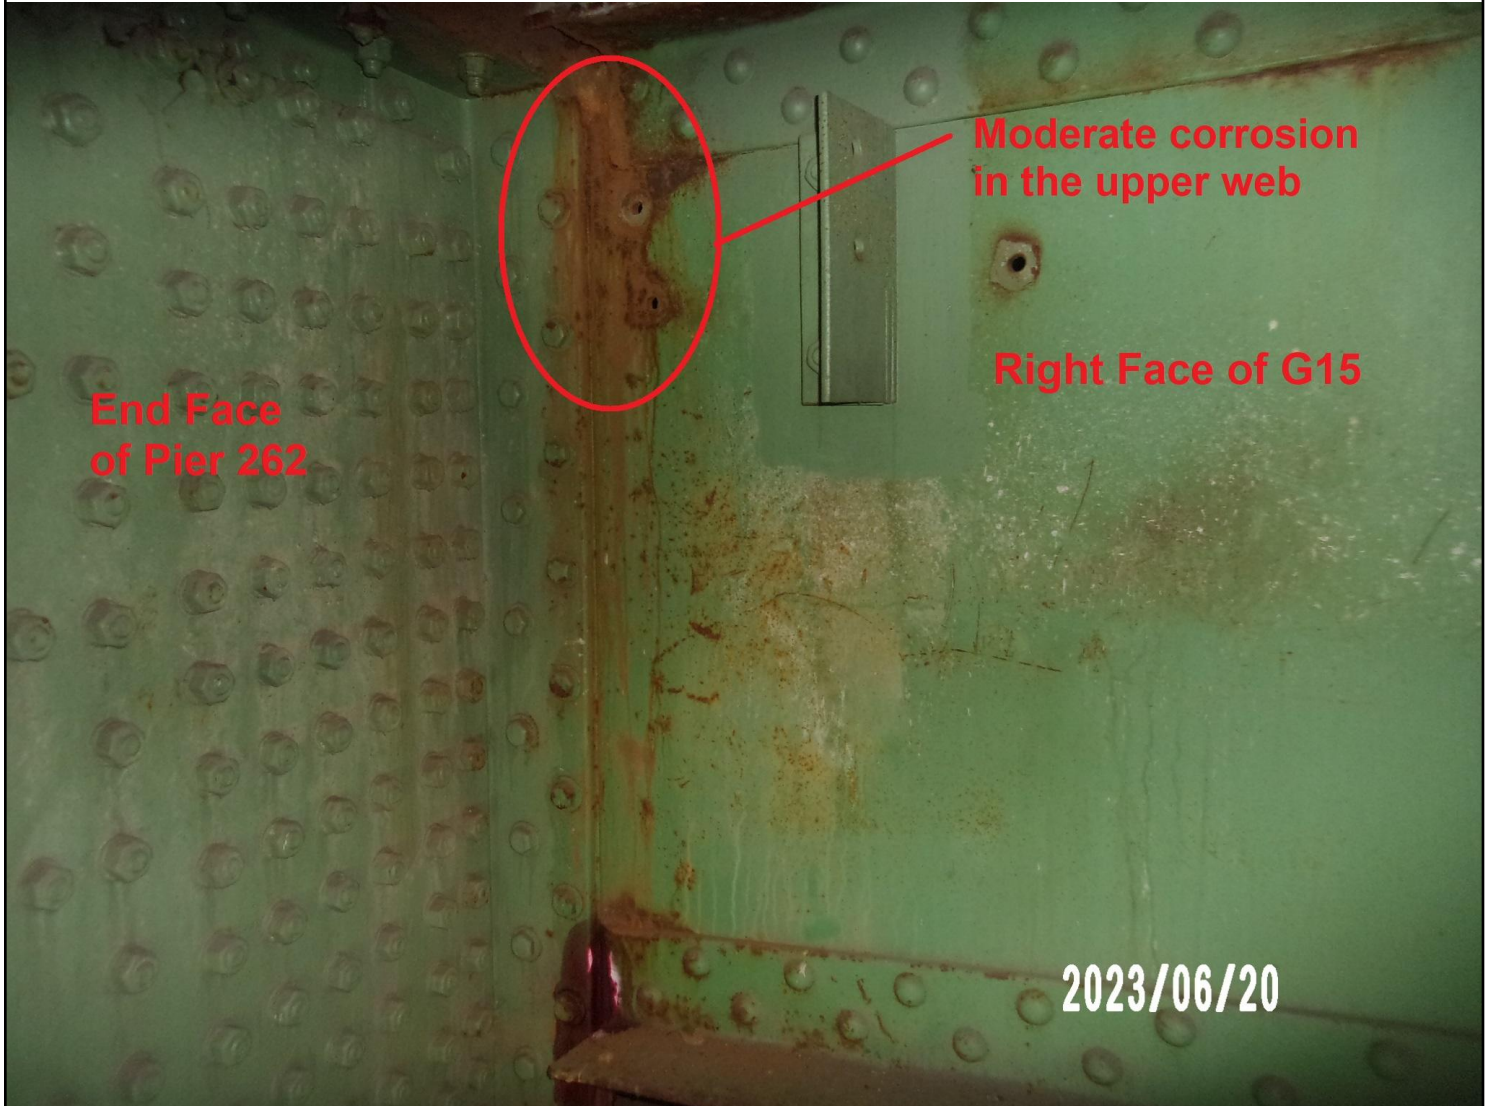
Photo Number: 4

**Attachment Description:** The right face of Girder G15 in Span 263 at Pier 262. The upper web of the girder exhibits moderate corrosion with no significant section loss throughout the girder height. Looking Left.

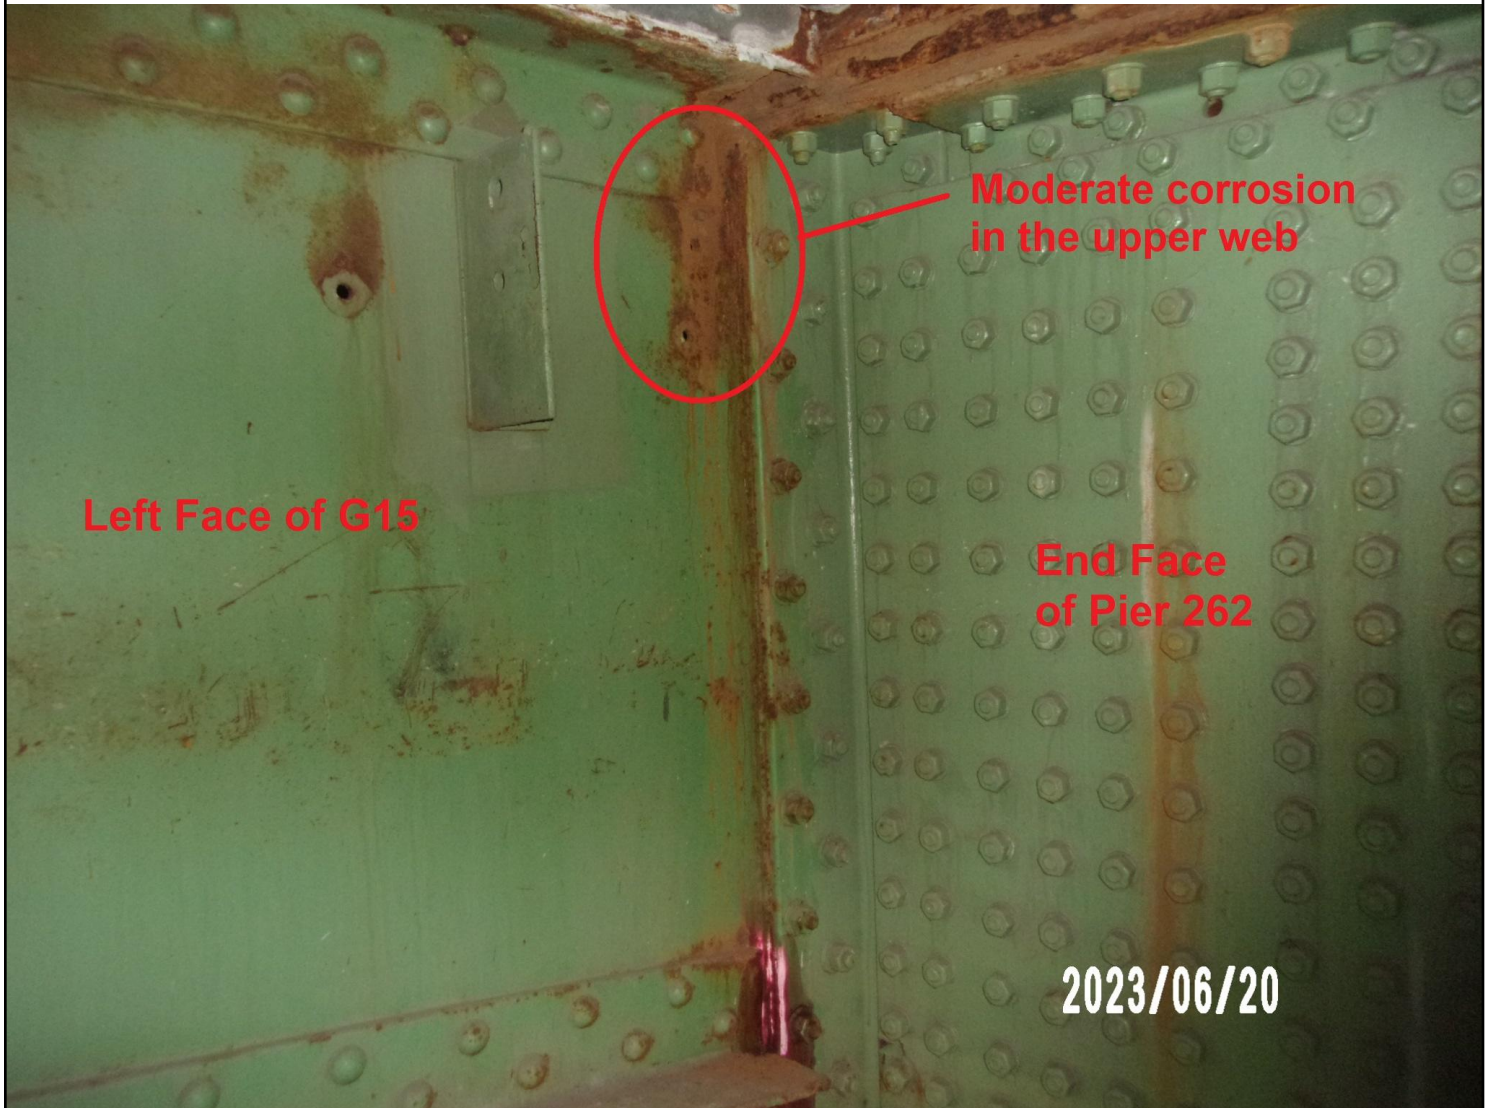
Photo Number: 5

**Attachment Description:** The left face of Girder G15 in Span 263 at Pier 262. The upper web of the girder exhibits moderate corrosion with no significant section loss throughout the girder height. Looking Right.

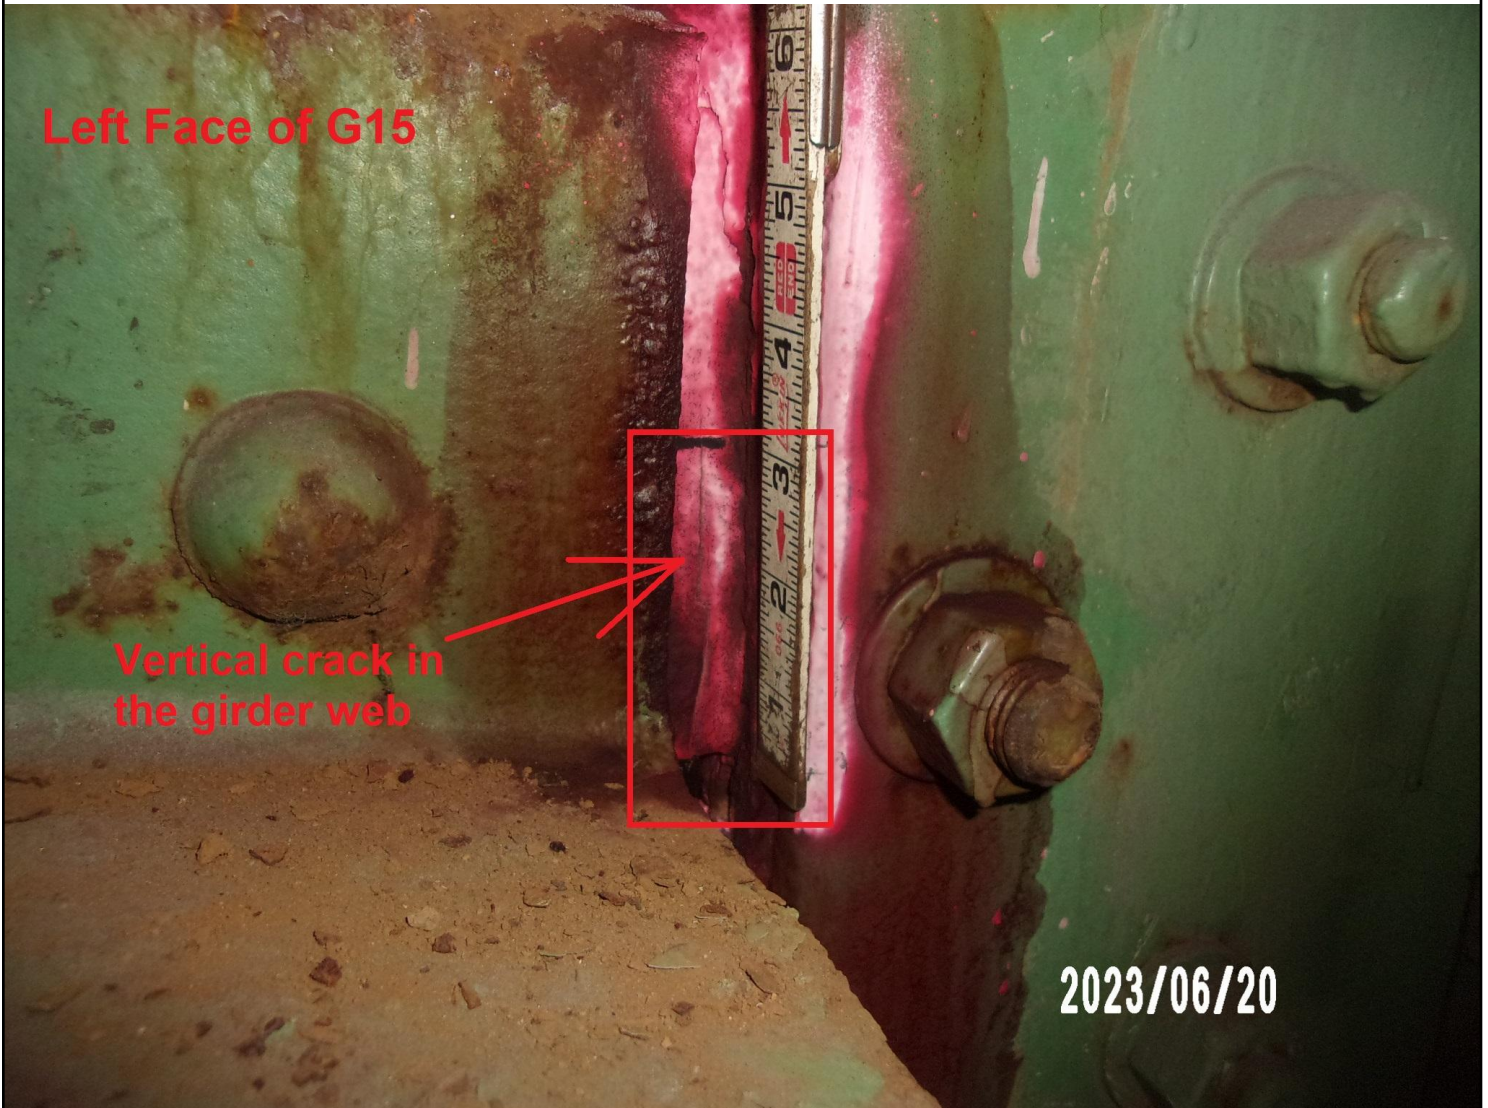
Photo Number: 6

**Attachment Description:** The left face of Girder G15 in Span 263 at Pier 262. The lower girder web exhibits a 3" long vertical crack adjacent to the connection angle. Looking Right.
